SSE Generation Limited

the £130M Collapse at Loch Ness

The recent findings of Lord Woolman attributing the burden of around £130M in rectification works of a brand new hydroelectric tunnel on the Client in a design and build contract has lessons and implications for the tunnelling industry in the United Kingdom and internationally.

By Professor Arnold Dix, Lawyer and Scientist, and CEO of the ALARP group of companies.

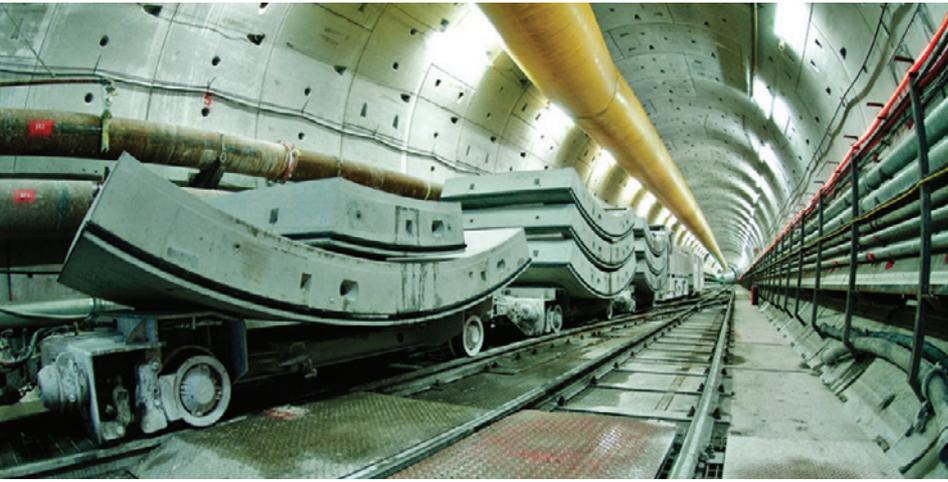
Above: A view down London's Lee Tunnel showing the segments being delivered to the deep sewer tunnel (p23)

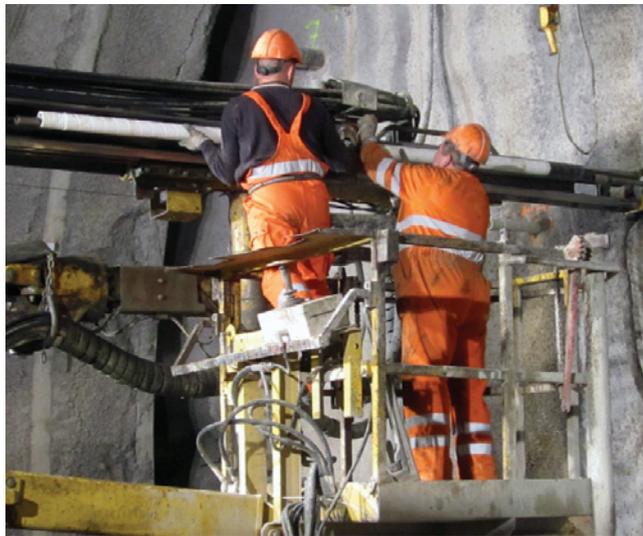
Left: Drill and Blast techniques still provide solutions for tunnel projects in the correct conditions, unsuitable for TBMs (p56)

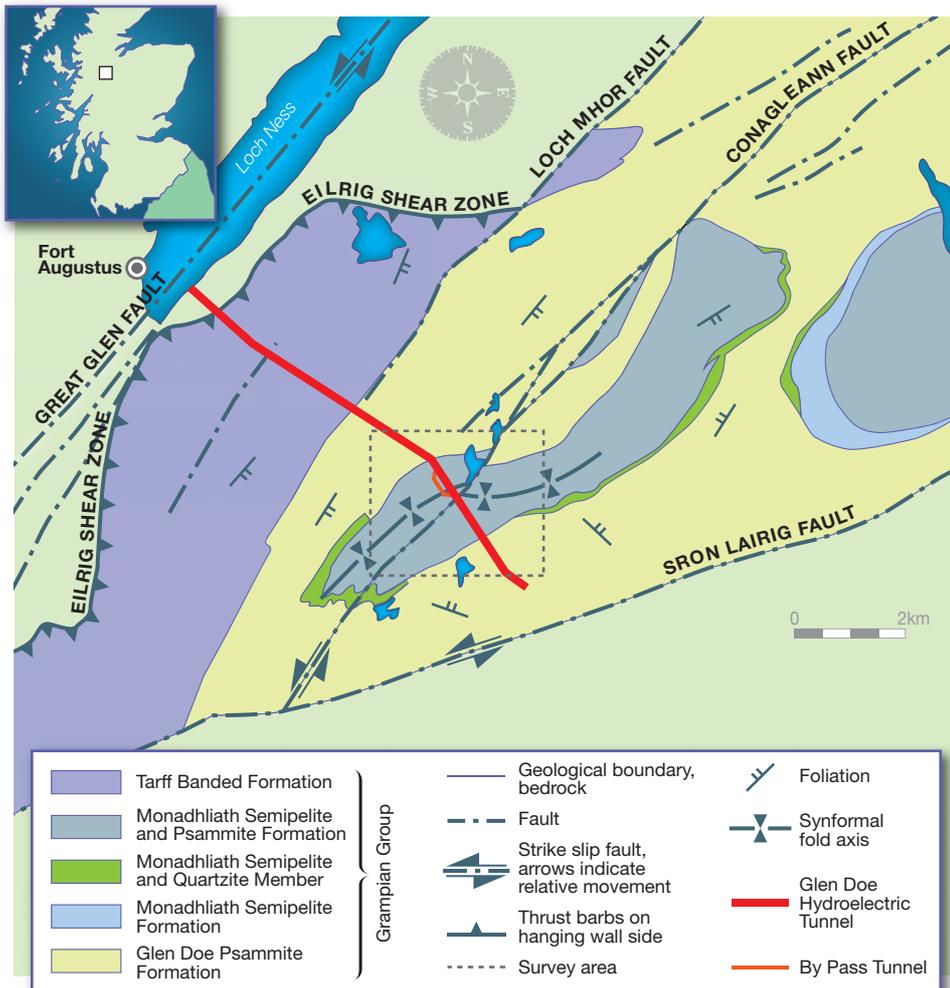
Figure 1: Plan map of the project location and geology

The Glendoe Scheme required the construction of the head race tunnel

through the Conagleann Fault Zone (“CFZ”). This zone was identified from the outset as posing a risk to tunnel integrity. A note by Lord Wolman:
